I Street Townhomes

Level 1 Reserve Study

Client Reference Number	19107
Property Type	Townhouse
Number of Units	22
Fiscal Year End	12/31

Type of Study	Full Study
Date of Property Inspection	07/10/2023
Prepared By	Dale Gifford
Analysis Method	Cash Flow
Funding Goal	Full Funding

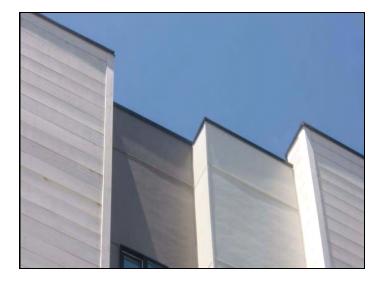
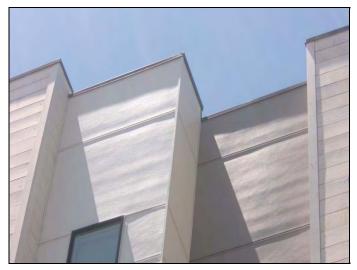
Comp #: 104 Flat Roofs - Replace

Unable to inspect this component at the time of the site visit. We recommend funding to replace this component approximately every 20 - 25 years. Remaining life based on current age.

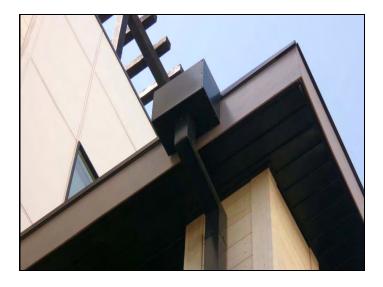
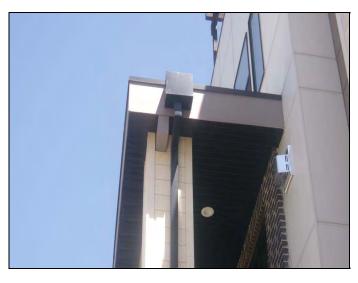
Comp #: 120 Rain Gutters/Downspouts - Replace

The rain gutters and downspouts are in good condition. We recommend funding to replace this component approximately every 25 - 30 years. Remaining life based on current age.

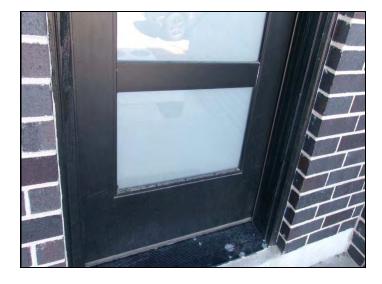
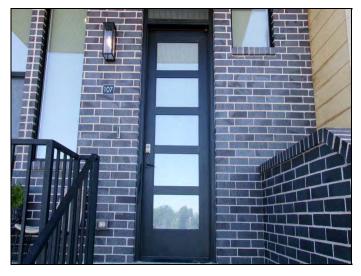
Comp #: 204 Front Doors - Repaint

Location:	Unit Entrances		
Quantity:	(22)	Doors	
Life Expectancy: Best Cost:	N/A \$0	Remaining Life:	
Worst Cost:	\$0

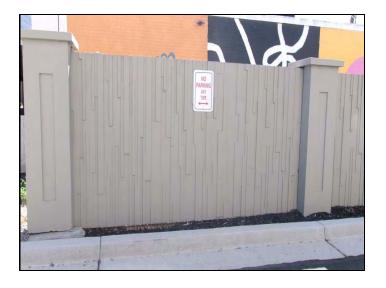
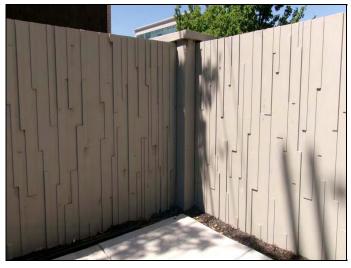
Comp #: 208 Prefab Concrete Fence - Repaint

The painted surfaces are in good condition. We recommend funding to repaint this component approximately every 10 - 12 years. Remaining life based on current age.

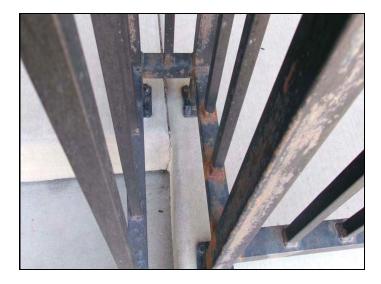
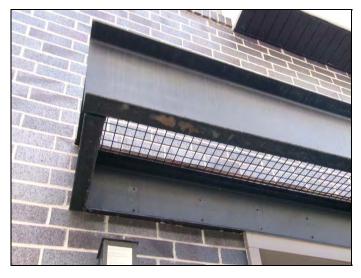
Comp #: 212 Metal Surfaces - Repaint

The painted metal railing surfaces are in fair condition. We recommend funding to paint this component approximately every 6 years. Remaining life based on current condition.

Projects programmed to occur this fiscal year (FY2024) include metal surfaces repaint (Comp# 212). We have programmed an estimated \$18,000 in reserve expenditures toward the completion of these projects. (See page 15)

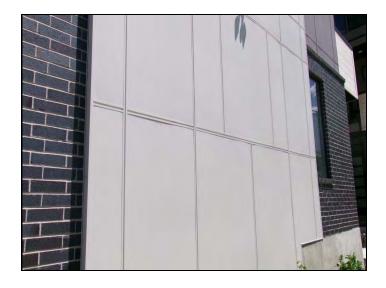
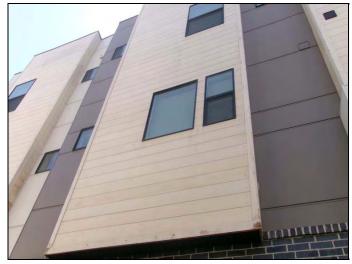
Comp #: 215 Siding - Repair/Repaint

The siding painted surfaces are in good to fair condition. We recommend funding to repair/repaint this component approximately every 8 - 10 years. Remaining life is based on current age.

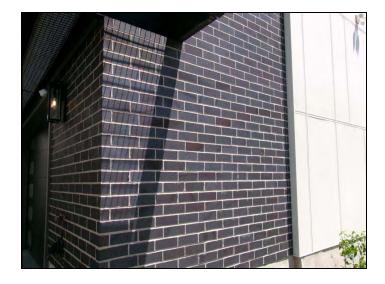
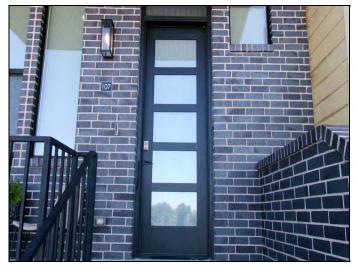
Comp #: 390 Brick Façade - Replace

Location:	Build	ing Exteriors
Quantity:	Appro	ox. 10,125 SF
Life Expectancy:	N/A	Remaining Life:
Best Cost:	\$0

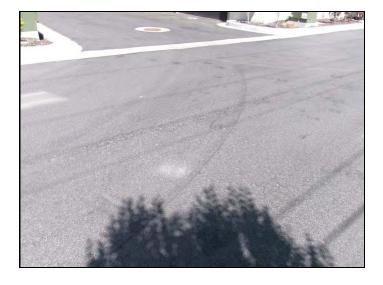
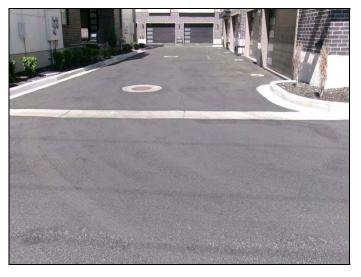
Comp #: 401 Asphalt - Major Rehab

The asphalt surfaces are in good condition. We recommend funding for a major rehab of this component approximately every 25 - 30 years. Remaining life based on current age.

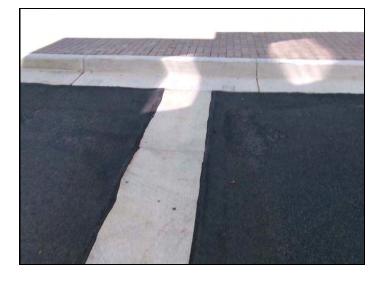
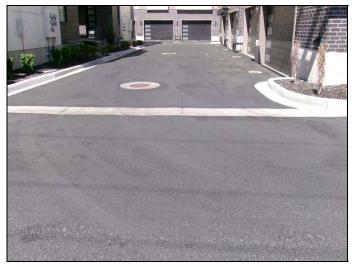
Comp #: 402 Asphalt - Seal Coat

The asphalt seal coat is in good condition. We recommend funding to seal this component approximately every 3 - 5 years. Remaining life based on current age.

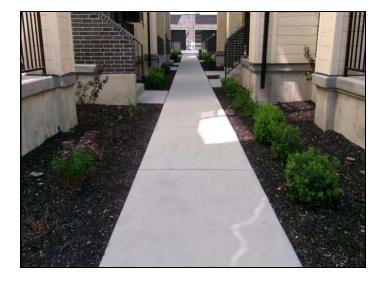
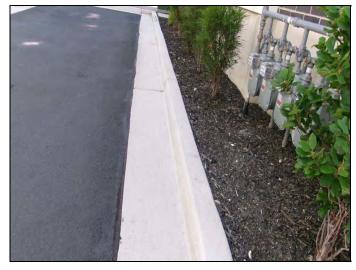
Comp #: 403 Concrete - Partial Repair/Replace

The concrete is in good condition. This component has an extended useful life under normal conditions. We recommend funding to make repairs and partially replace this component approximately every 10 years. Remaining life based on current age.

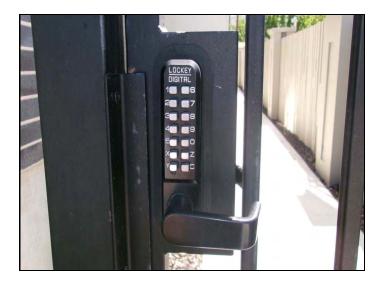
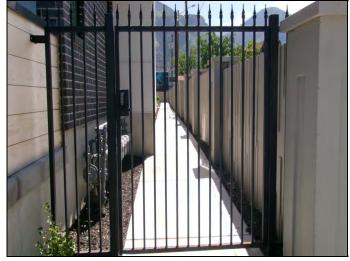
Comp #: 504 Pedestrian Gate - Replace

The pedestrian gate is in good condition. We recommend funding to completely replace this component approximately every 25 - 30 years. Remaining life based on current age.

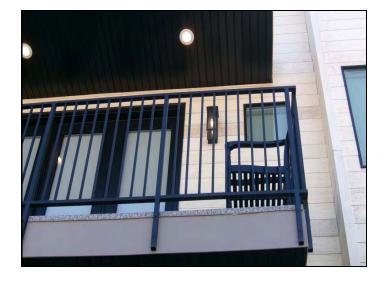
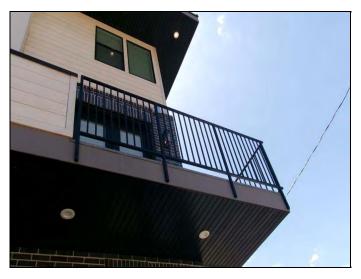
Comp #: 604 Balcony Decks - Resurface

Unable to inspect this component at the time of the site visit. We recommend funding to resurface this component approximately every 15 - 20 years. Remaining life based on current age.

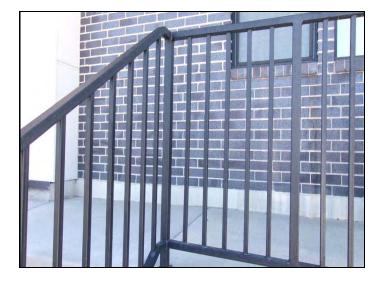
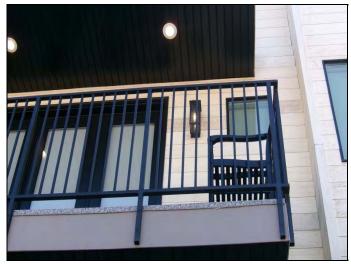
Comp #: 690 Metal Railing - Replace

The deck railing is in good condition. We recommend funding to replace this component approximately every 40 - 50 years. Remaining life based on current age.

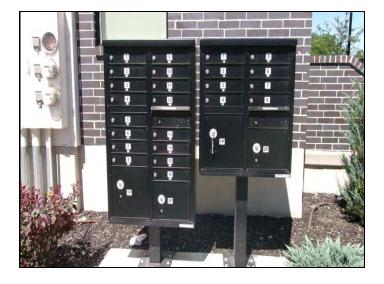
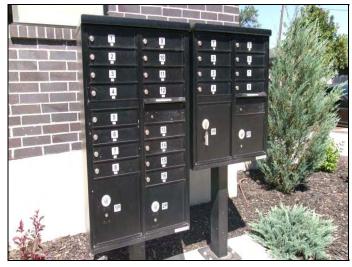
Comp #: 803 Mailboxes - Replace

Location:	Common Area	
Quantity:	(2) Clusters	
Life Expectancy: Best Cost:	N/A \$0	Remaining Life:
Worst Cost:	\$0

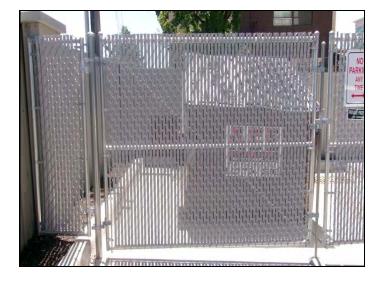
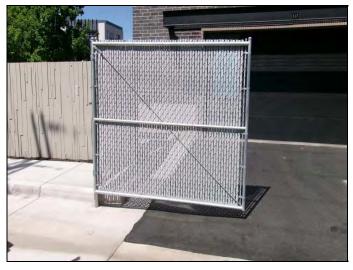
Comp #: 1003 Trash Enclosure Gates - Replace

The chain link fencing is in good condition. We recommend funding to replace this component approximately every 30 - 40 years. Remaining life based on current age.

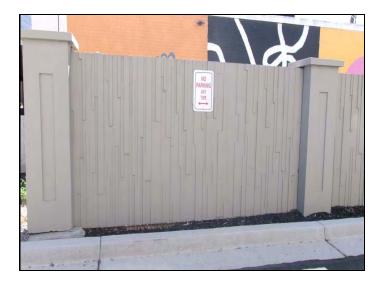
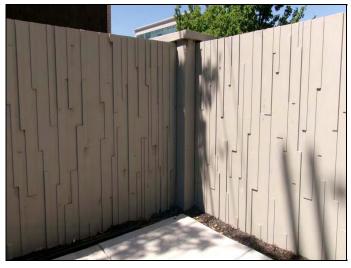
Comp #: 1012 Prefab Concrete Fence - Replace

This type of component should have an extended useful life under normal conditions. Reserve funding is not appropriate.

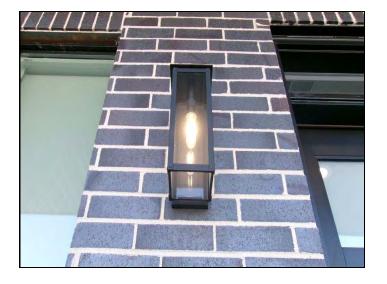
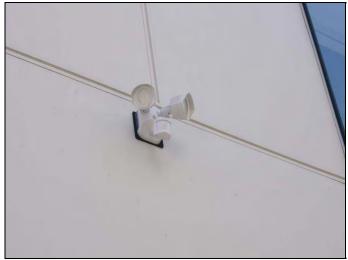
Comp #: 1602 Exterior Light Fixtures - Replace

The exterior light fixtures are in good condition. We recommend funding to replace this component approximately every 16 - 20 years. Remaining life based on current age.

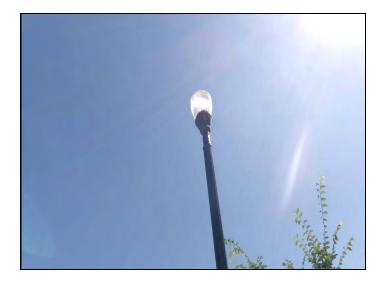
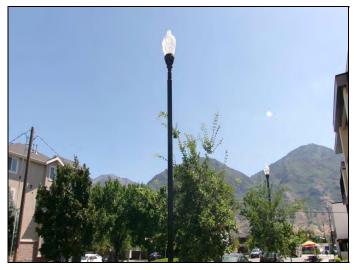
Comp #: 1609 Street Light Fixtures - Replace

The street light fixtures are in good condition. No expectation to replace the light poles. Paint poles as necessary as an operating expense. We recommend funding to replace this component approximately every 20 years. Remaining life based on current age.

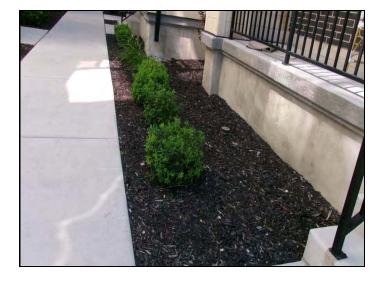
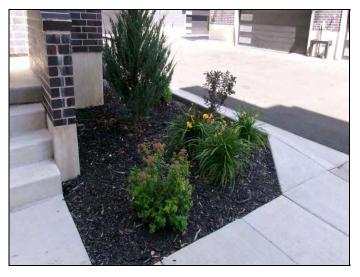
Comp #: 1812 Landscaping & Irrigation System - Renovate

The landscaping and irrigation system appear to be in good condition. We recommend funding for an allowance to renovate this component approximately every 20 years. Remaining life based on current age.
